# Manhole Inspection Summary

Manhole # S45II\_045MH

Insp Date: **4/30/08 10:10 AM**

**Location** Address: **Chester St**

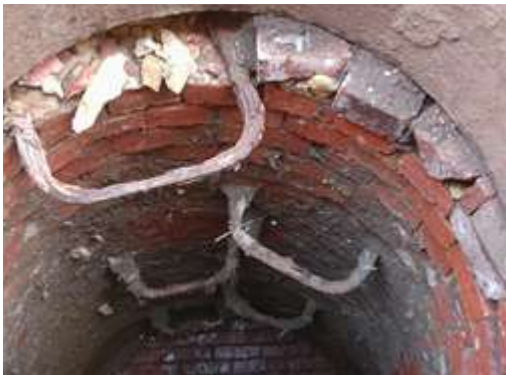
Defect 2

Condition: ☐ Sound ☐ Cracked ☐ Root Intrusion ☒ **Loose Brick** ☐ Deteriorated

Deterioration/Loose Bricks

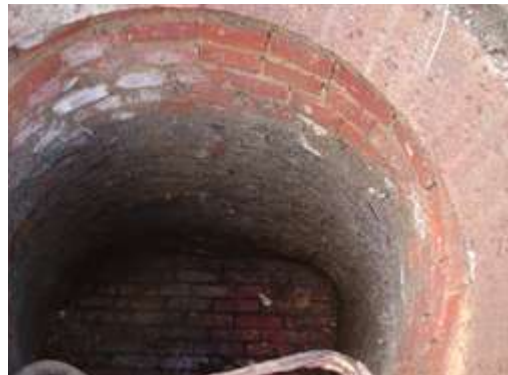
Defect 1

Infiltration: ☐ None ☐ Joint ☐ Cracks ☒ **Mortar** ☐ Roots ☐ Wall

Infiltration

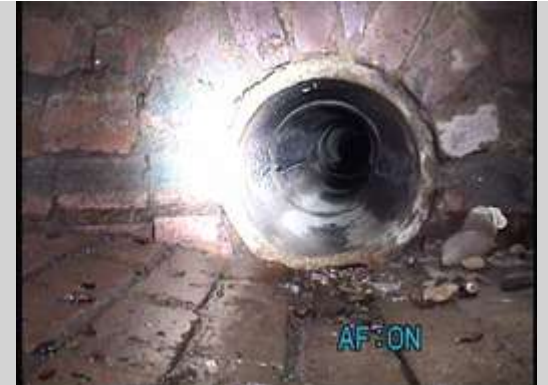
12 O'Clock Outflow

8 in. Circular Gravity Sewer  
Pipe Out @ 12 O'Clock

Pipe Height: **8.4** (in.) Rod and Bar (Angled)  
Pipe Material: **Clay** ☐ Pipe Lined  
Invert Depth: **8.45** (ft.) Flow Characteristics: **None**  
Deposits: ☒ None ☐ Mud ☐ Sludge ☐ Debris ☐ Grease  
Silt Depth: (in.) Deposits Extent:  
Infiltration: **None** Pipe Seal Cond: **Sound**

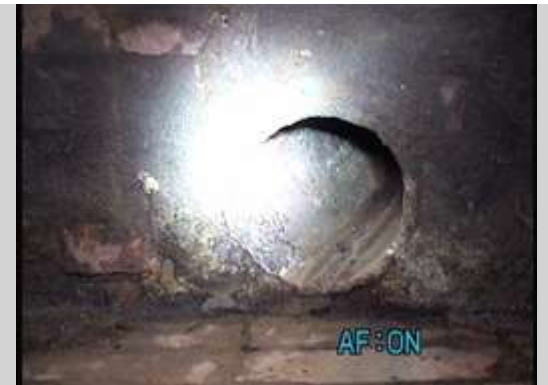
3 O'Clock Inflow

6 in. Circular Gravity Sewer  
Pipe In @ 3 O'Clock

Pipe Height: **6** (in.) Rod and Bar (Angled)  
Pipe Material: **Clay** ☐ Pipe Lined  
Invert Depth: **8.00** (ft.) Flow Characteristics: **None**  
Deposits: ☒ None ☐ Mud ☐ Sludge ☐ Debris ☐ Grease  
Silt Depth: (in.) Deposits Extent:  
Infiltration: **None** Pipe Seal Cond: **Sound**
